BIG DELTA STATE HISTORICAL PARK RIVERBANK RESTORATION FEASIBILITY STUDY

**By
Christopher H. Roach P.E., Consulting Engineer
April 2005**

Rika’s Roadhouse – A Discussion on Bank Protection Alternatives

November 2004

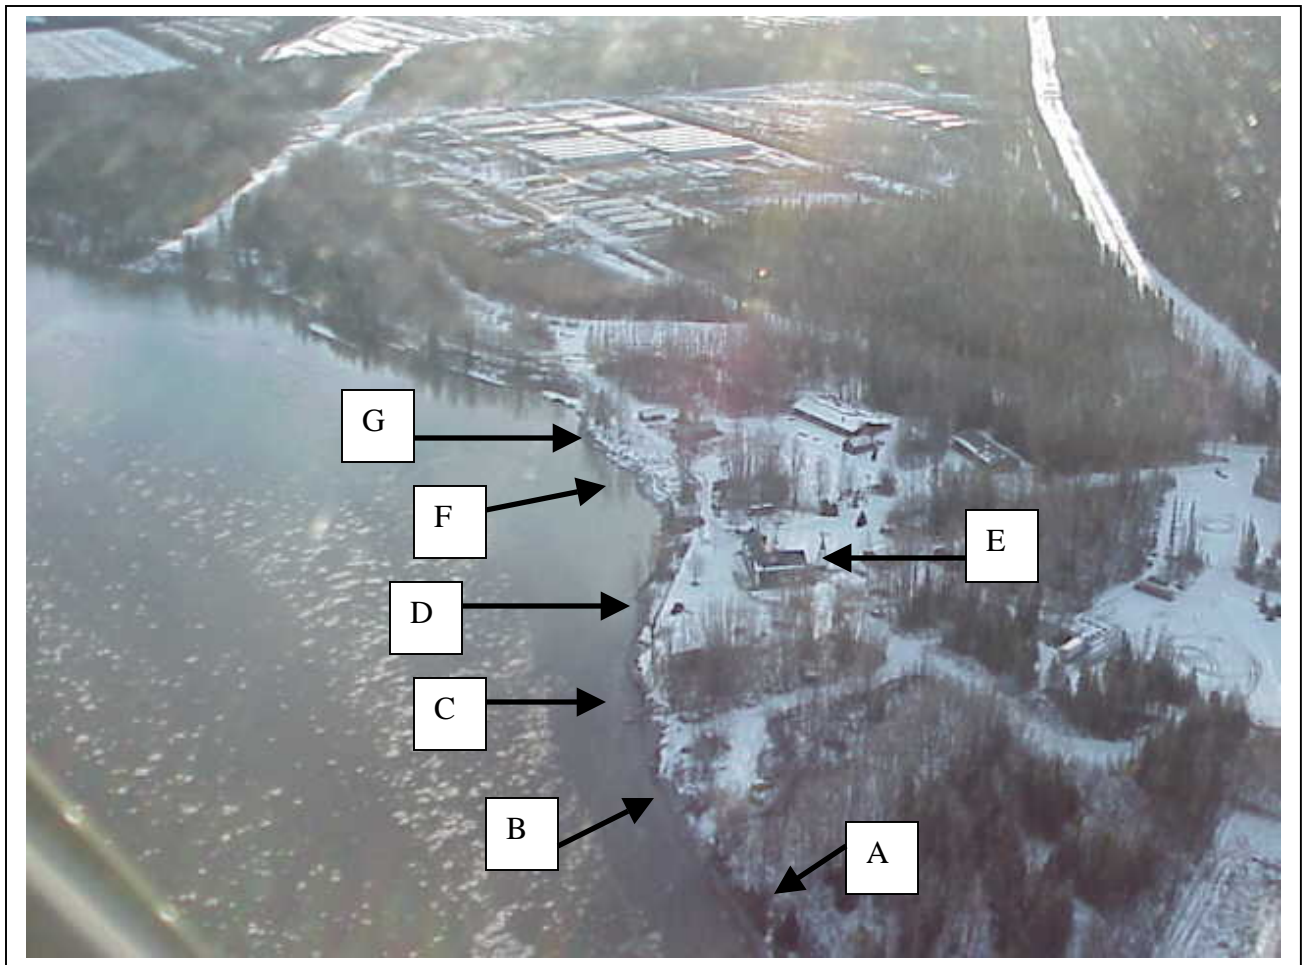
Figure 1: Aerial oblique photo, looking upstream at Rika's Roadhouse Property

The site is located on the left bank of the Tanana River on a mild right bend upstream of the Richardson Highway and Trans Alaska Pipeline, Figure 1. The river is bounded by relatively high banks within this reach and has a braided channel morphology at Rika's. The reach directly in front of Rika's has developed a minor cove with a shallow shelf extending out into the stream bed. This shelf has active spring flows which are important to the viability of spawning beds within this reach. At the time of the site visit active spawning was ongoing within this reach. A small parcel of private land is located downstream, and adjacent to, the Rika's property. Downstream of this private parcel, the banks appear to be in a natural state with no evidence of clearing or disturbance of riparian vegetation, representing the condition of the banks and riparian vegetation prior to clearing and removal of vegetation.

- Point A: Stable bank downstream of private property (downstream of Rika's property)
- Point B: Private property downstream of Rika's property
- Point C: Boat launch, lower section of Rika's property in front of Ferryman's cabin
- Point D: Point in front of Rika's Roadhouse Building
- Point E: Rika's Roadhouse Building
- Point F: Alcove upstream of Rika's Roadhouse Building with shallow shelf and log crib ferry dock structure
- Point G: Point upstream of Rika's Roadhouse Building

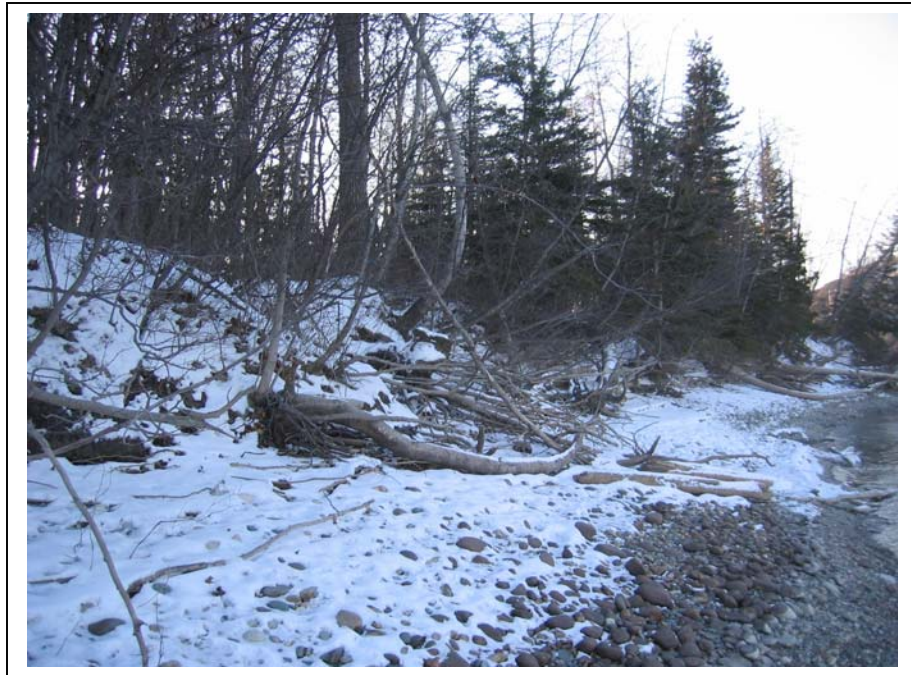
The left bank appears to be undisturbed in this reach, with no evidence of any vegetation clearing, Figure 2. No recent bank erosion was visible. Several mature trees within this reach are growing out diagonally from the bank, with the upper 10 to 12 feet of the tree turning vertically. This indicates that, at some time in the past, the bank slumped, but the trees and other vegetation have continued growing and the bank has been stable for many years. A number of mature birch, cottonwood, and spruce trees are located in this reach, and the bank is covered by dense vegetation.

Two distinct zones are evident on the bank within this reach: The zone above Ordinary High Water (OHW) characterized by stable vegetation and a bank height of approximately 5 feet (the bank above OHW is likely composed of silts stabilized by vegetation); and the zone below OHW, characterized by a distinct shallow angle transition to the stream bed which is composed of gravel and cobbles. This transition zone defines the "toe" of the upper bank. This distinction will be important in the discussion of observed bank erosion to follow.

Figure 2: Looking downstream at stable bank with undisturbed vegetation. Note density of vegetation, prevalence of mature trees, and lack of any recent bank erosion

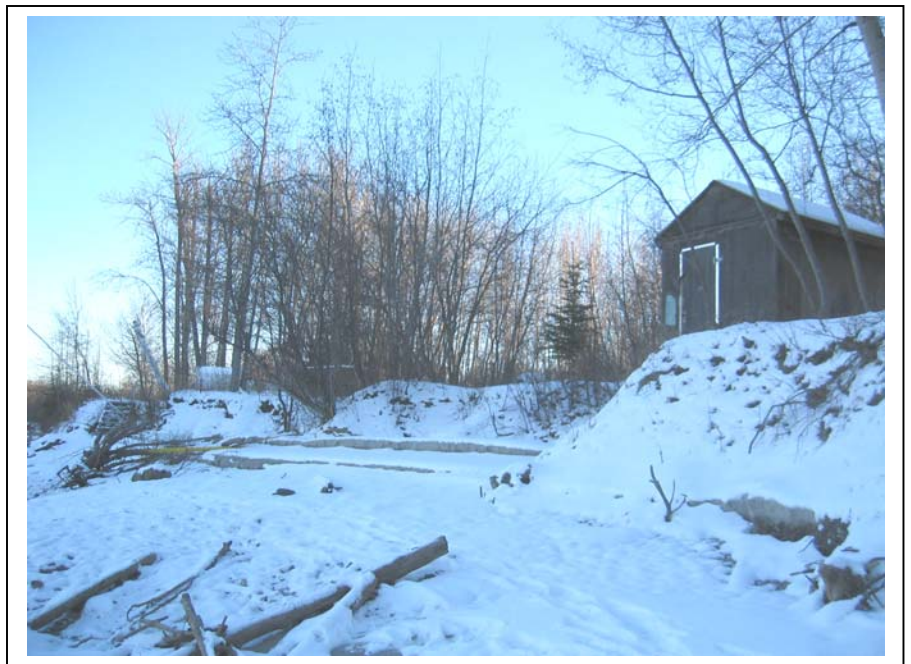
A distinct change in vegetation is evident compared with the reach immediately downstream, Figure 3 and 4. It is clear that a significant amount of vegetation has been removed from the upper bank. This section of riverbank exhibits the most severe land loss of the entire section that was evaluated, with bank erosion on the order of 20 feet or more in at least two locations. The "toe" of the slope, which is comprised of gravels and cobbles transitioning into the stream bed, appears to be relatively unchanged compared to the downstream reach (i.e., virtually all of the land loss occurred above OHW where bank vegetation has been removed, while the toe of the slope does not appear to be moving).

Figure 3: View looking upstream from same location as Figure 2, showing change in vegetation and active bank erosion at private property.

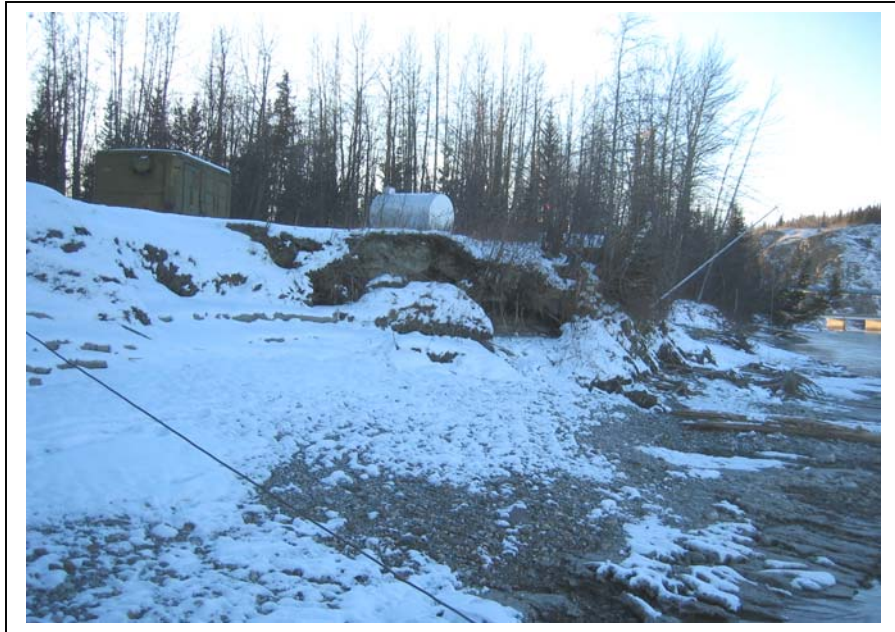
Figure 4: Looking downstream from Rika's Roadhouse boat dock at private property and stable bank beyond. Note contrast in vegetation from upstream to downstream and associated bank erosion above OHW.

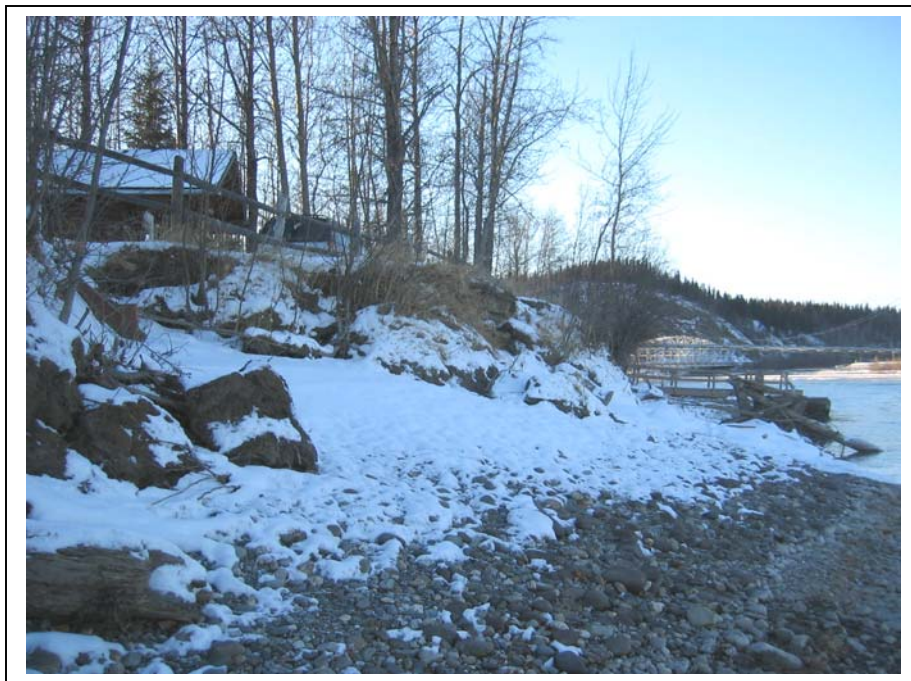
This includes the "Ferryman's cabin", boat launch, and the bank downstream of the "riprap point" discussed below, Figure 5. Similar to the private property downstream, a distinct change in vegetation is evident compared with the downstream stable reach. Changes in vegetation include a significant reduction in vegetation density, the near absence of mature trees, and a change in vegetation species. Recent bank erosion and land loss was evident, with several distinct failures of the bank above OHW clearly visible. The toe of the slope below OHW appears to be relatively unchanged (i.e., virtually all of the land loss occurred above OHW and the toe of the slope does not appear to be moving).

Figure 5: Active bank erosion of upper bank in front of Ferryman's Cabin

- In areas with significant land loss, such as the downstream reach on Rika's near the Ferryman's cabin and boat launch, this would involve excavating down to the OWH elevation and reconstructing the bank using soil wraps, coir logs, willow brush layering, and revegetation of the re-constructed bench. The advantage of this approach is that the historic bank line can be restored (i.e. restore the bank out to near the 1998 position, thereby regaining some of the land that was lost to bank erosion since that time), which would allow an increased buffer to be established between existing structures and the new edge of bank. The new bank should be designed and constructed to be flexible to allow some minor settlement to occur without failure of the bank, which would accommodate minor changes in the toe of the slope below OWH. Some additional information will be needed to determine the proper soil mix

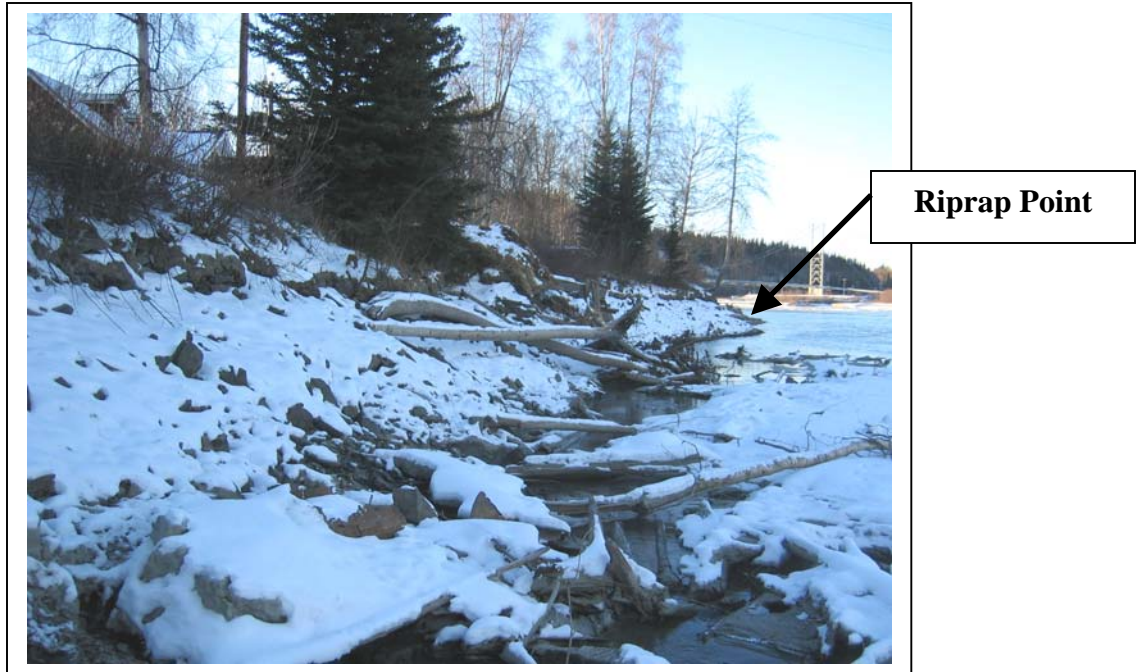
A small point in front of Rika’s was armored in the 1950’s with riprap (according to ADNR/USFWS discussions with the concessionaire historian), Figure 6. This riprap is still present and appears to be stable even though it is of marginal quality. The slope shows no evidence of recent movement. A relatively deep scour hole has developed at the base of the riprap slope, and limited riprap appears to remain at the toe of the slope near the pool. The top of the riprap is at approximately the OHW elevation. Above OHW the bank appears to be relatively stable. The upper bank has several mature trees. It appears that the vegetation on the upper bank has been selectively thinned, possibly to promote growth of wild roses and a view of the river in front of the Rika’s Roadhouse building.

Figure 6: View of “Riprap Point” in front of Rika’s Roadhouse Building.

- Riprap toe protection. This may be appropriate at the “point” in front of the Rika’s Roadhouse Building which was protected in the 1950’s with riprap. This slope has riprap up to approximately the OHW elevation and some loss of riprap may have occurred at the toe of the slope. A limited amount of riprap toe protection at the base of this slope would increase the stability of the upper slope. It is possible to place the riprap from above the bank using a track hoe, thus minimizing disturbance in this area. This may also be appropriate at the “point” upstream of the Rika’s Roadhouse Building, at the toe of the steep slope below OHW, in lieu of the root wad revetment.

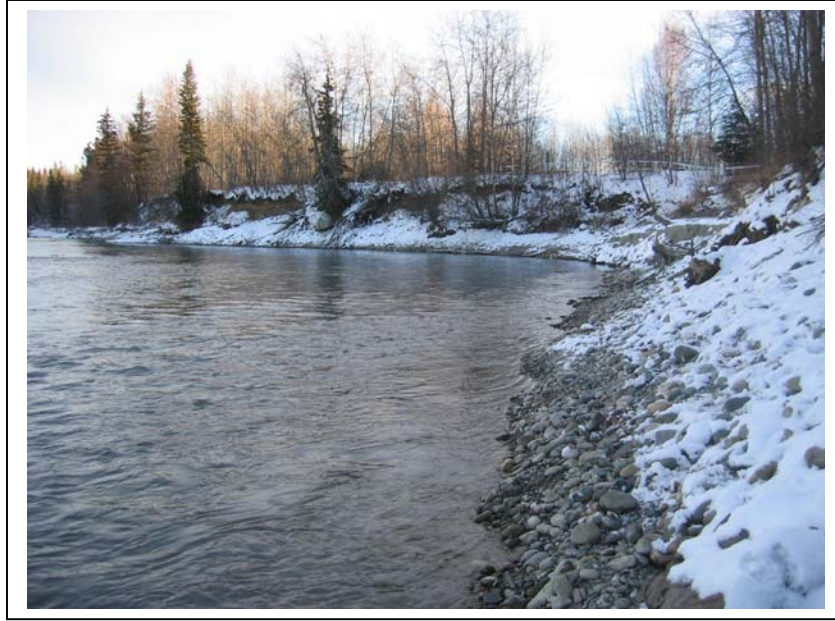
This point is characterized by a high upper bank with a steep gravel/cobble slope below OHW, Figure 8. Some failure of the upper bank is evident above OHW, with a few large blocks separated from the upper bank. The angle of the slope below OHW is approximately 1h:1v and is much steeper than any other location (downstream) described previously. The slope below OHW is comprised of cobbles with some gravel. Large cobbles are distributed throughout the base (toe) of the slope. The cobbles at the toe of the slope are covered with a heavy growth of algae, indicating that, in all likelihood, the toe of the slope is not being eroded rapidly but rather it is remaining relatively stable.

Figure 8: Point upstream of Rika's Roadhouse Building (foreground) and stable upstream bank beyond (see Figure 1 Point G for location of upstream point)

- Root wad revetment. A root wad revetment at the upstream section of the property, starting in the alcove upstream of the “point” (upstream of Rika’s Roadhouse Building), may be useful to stabilize the toe of the slope and form a bench to buttress the upper slope. The length of a root wad revetment structure would be limited, only as necessary to protect the lower bank at this point from erosion.

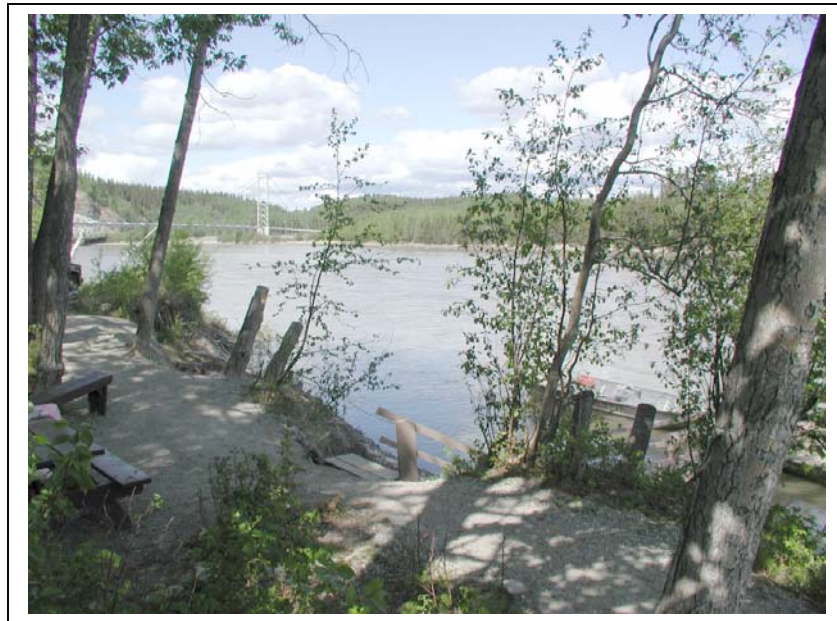
Figure 9: View of stairway leading down to boat dock. Note location of foot path and lack of vegetation of upper bank

Control of foot traffic will minimize trampling of bank vegetation and allow the re-vegetation effort to succeed, see Figure 9 for an example of a footpath directly along the bank which is having a negative impact on bank vegetation. In order to facilitate this, foot paths that are set back away from the bank should be developed (some are already in place). Boardwalks or platforms at viewing areas could be installed at discrete locations along the bank to allow for viewing the river while maintaining the integrity of the bank vegetation.
